**Flood Control Project Maintenance  
Levee Inspections**

**Fall 2016 Levee Maintenance Deficiency Summary Report**

**Levee District No. 0001 (Sutter County)**

**Levee Inspection Report By Mile - Fall 2016**

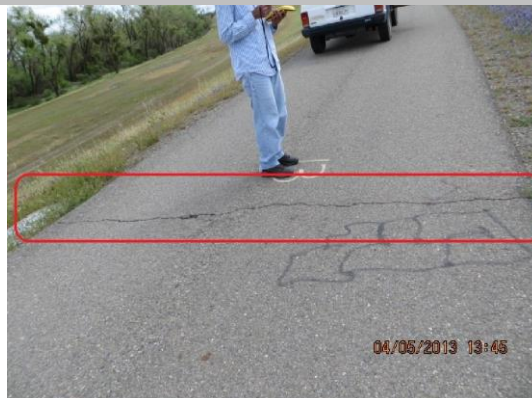
Photo 2 of 2 : UCIP\_FA\_2016\_50675\_19461.jpg

LM Start	11.39	Rating **	M	Issue No.	501
LM End	11.39	Issue Type +	En	Location *	LS
Category	Supplemental			GPS Latitude/Longitude	
				Start	End
Item	DWR UCIP Field Study			39.106261 °	39.106261 °
				-121.607535 °	-121.607535 °
DWR ID					
Comment Code					
Inspector Comment					
FS_ID:50675 DS_ID:18879 EP_NO: N/A Repair Type: Non-Urgent Crossing Status: Not Found UCIP Comments: 07/20/2016 Pipe and pump station removed as part of the Feather River West Levee Project. (K. Fazel - UCIP)04/05/2013 Road pavement cracked along pipe line, needs more investigation. (P. Amatya - DWR) FIELD_STRUCT_DESC: *REMOVED* 2 of 2. A 16-inch pipe (of 6-inch and 16-inch-pipes) through levee, 6.0 feet below crown. Flap gates on waterward end. Siphon breakers in corrugated metal pipe risers on waterward shoulder. Pump house at landward toe. FS Date: 7/20/2016

Levee crown overview- siphon breaker on right
